PLUM ISLAND BEACH

Feasibility Report

Newburyport - Newbury, Massachusetts

DECEMBER 1976

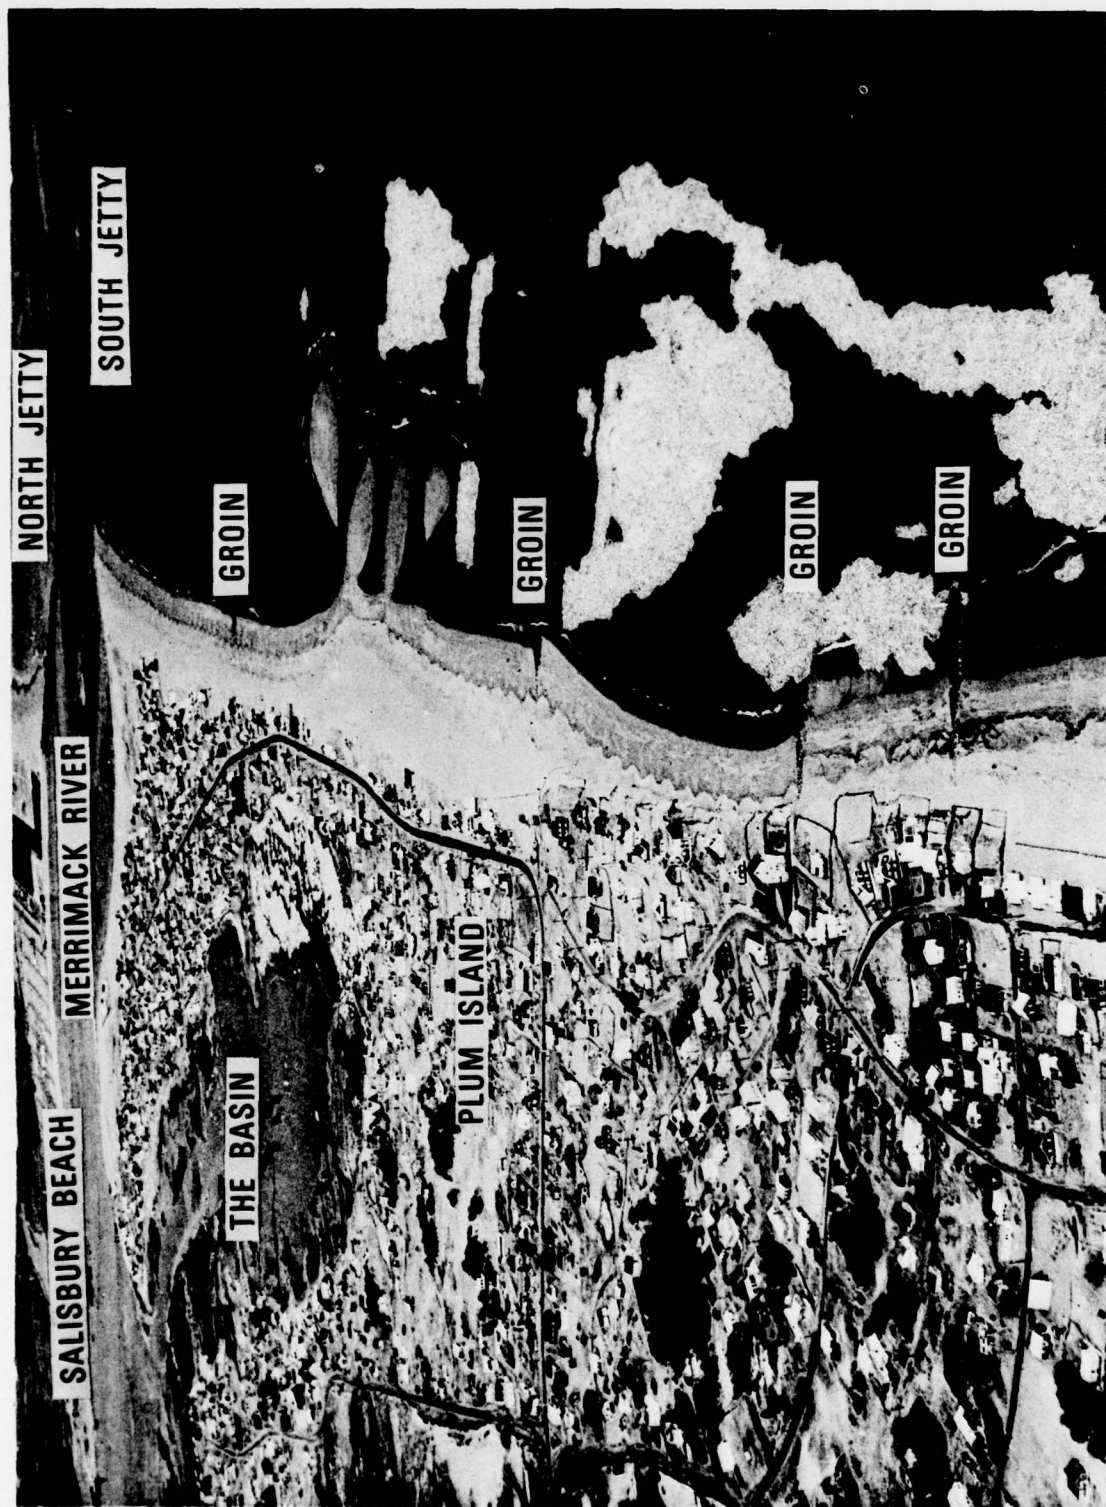
Photo 4. Looking north during mean low water in February 1976. Note the erosion and the accretion. As a result of several storms in February 1976.

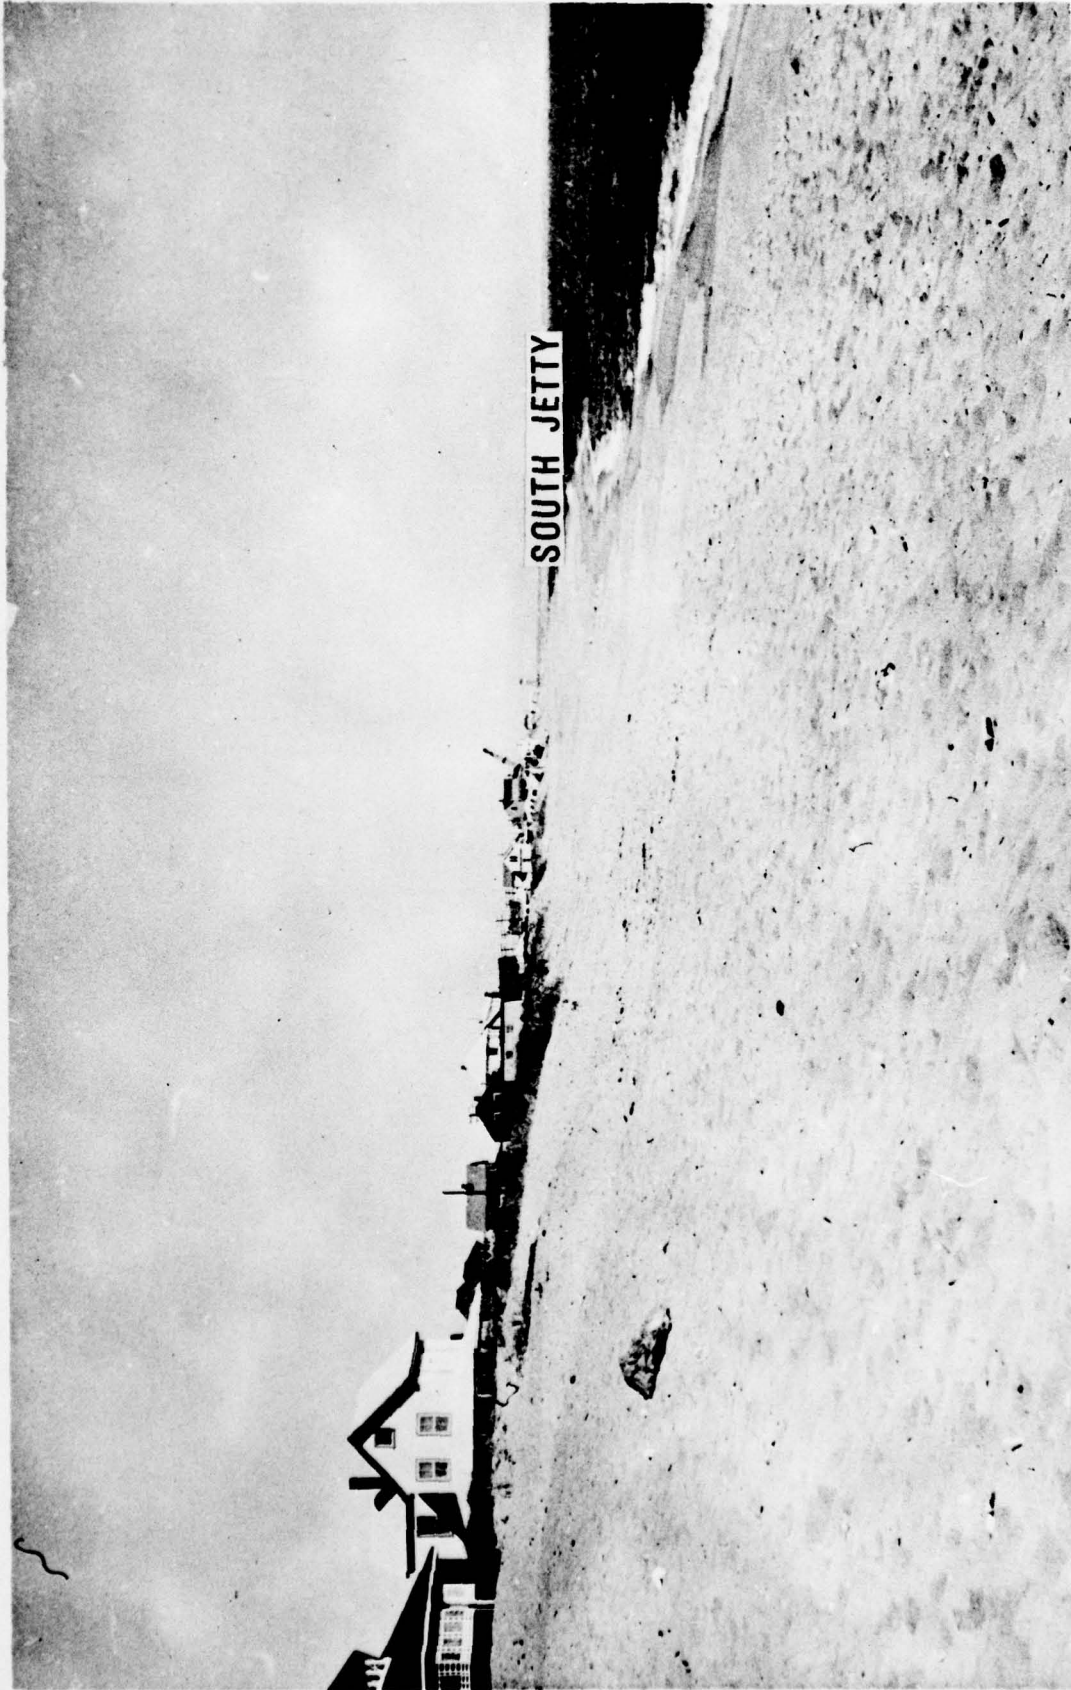
Photo 7. PLUM ISLAND 1966. Looking northerly of Plum Island Turnpike groin along wide protective beach and dunes that existed prior to the 19 February 1972 storm. Note this section of shore eroded as a result of a series of storms in 1972 (See Photo 8)

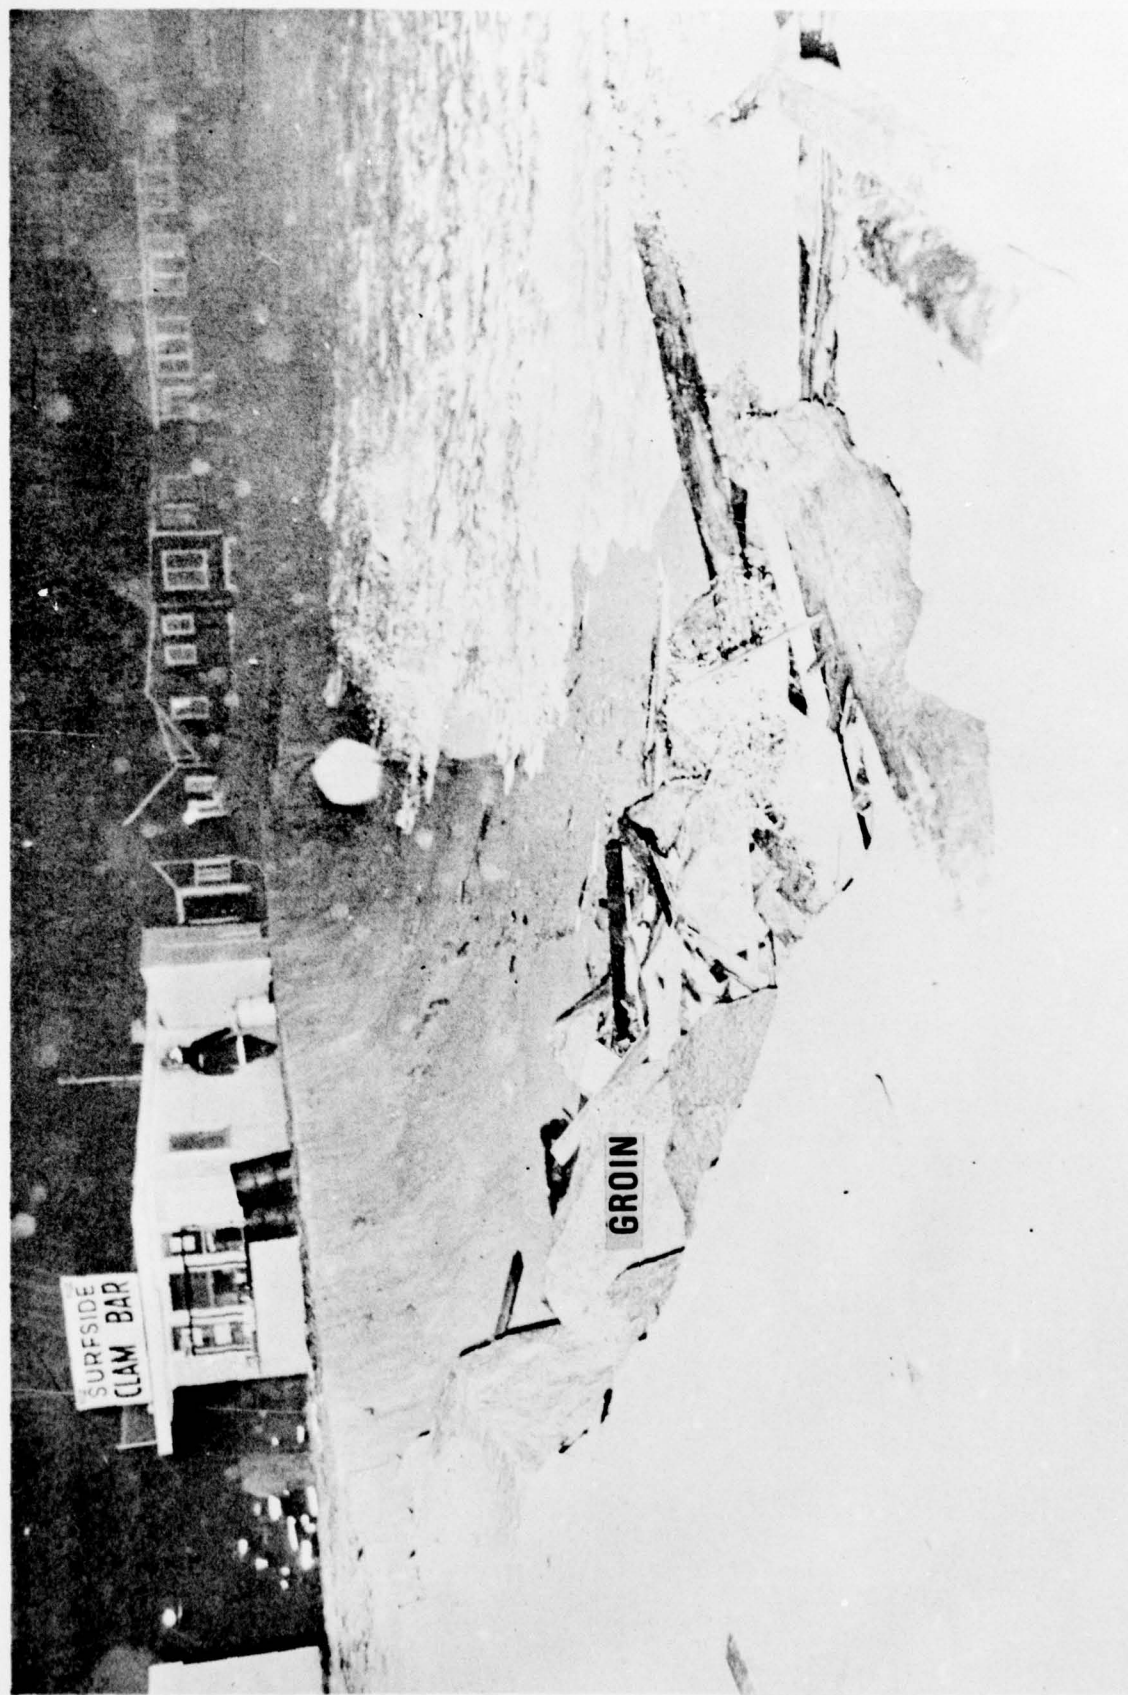
Photo 9. During September 1972 storm this structure was seriously damaged by the storm. This structure is located at the end of the Turnpike Road.

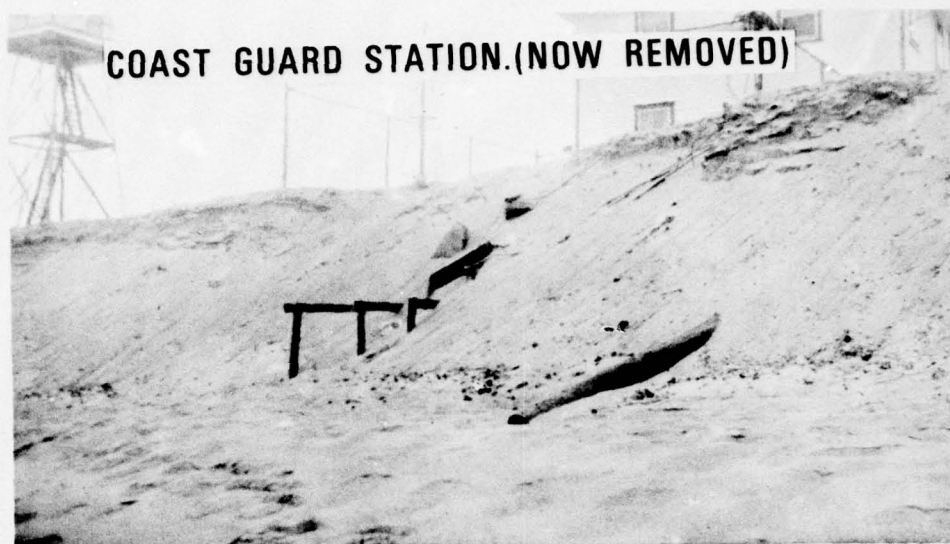
Photo 12. April 1969 Coast Guard Station in the background. Top of bank is now 45 feet from station. Spring tide approaches base of slope. Note - since this photo, the station has been removed and the shore revetted - (See Photo 21).

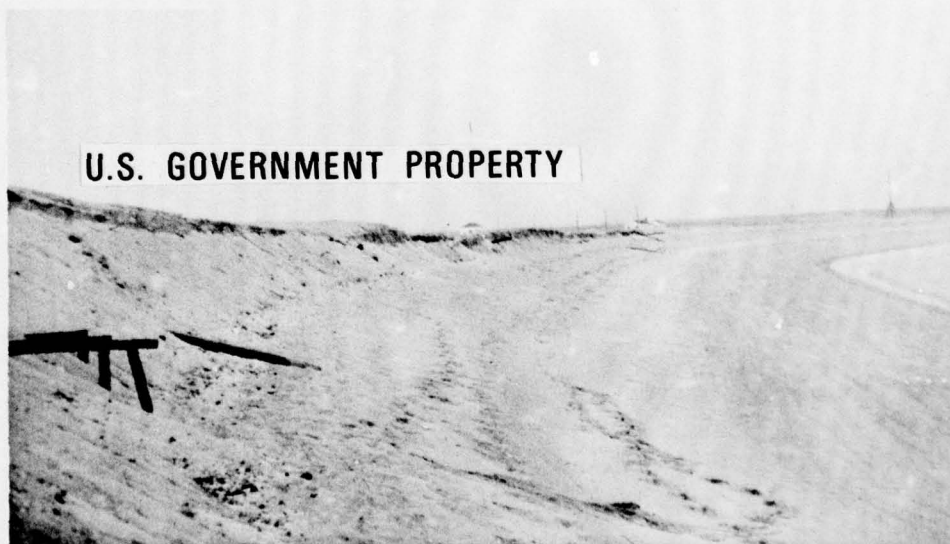
Photo 13. April 1969 Looking west along the south shore of the Merrimack River. Note eroding bank vicinity of the Coast Guard Station.

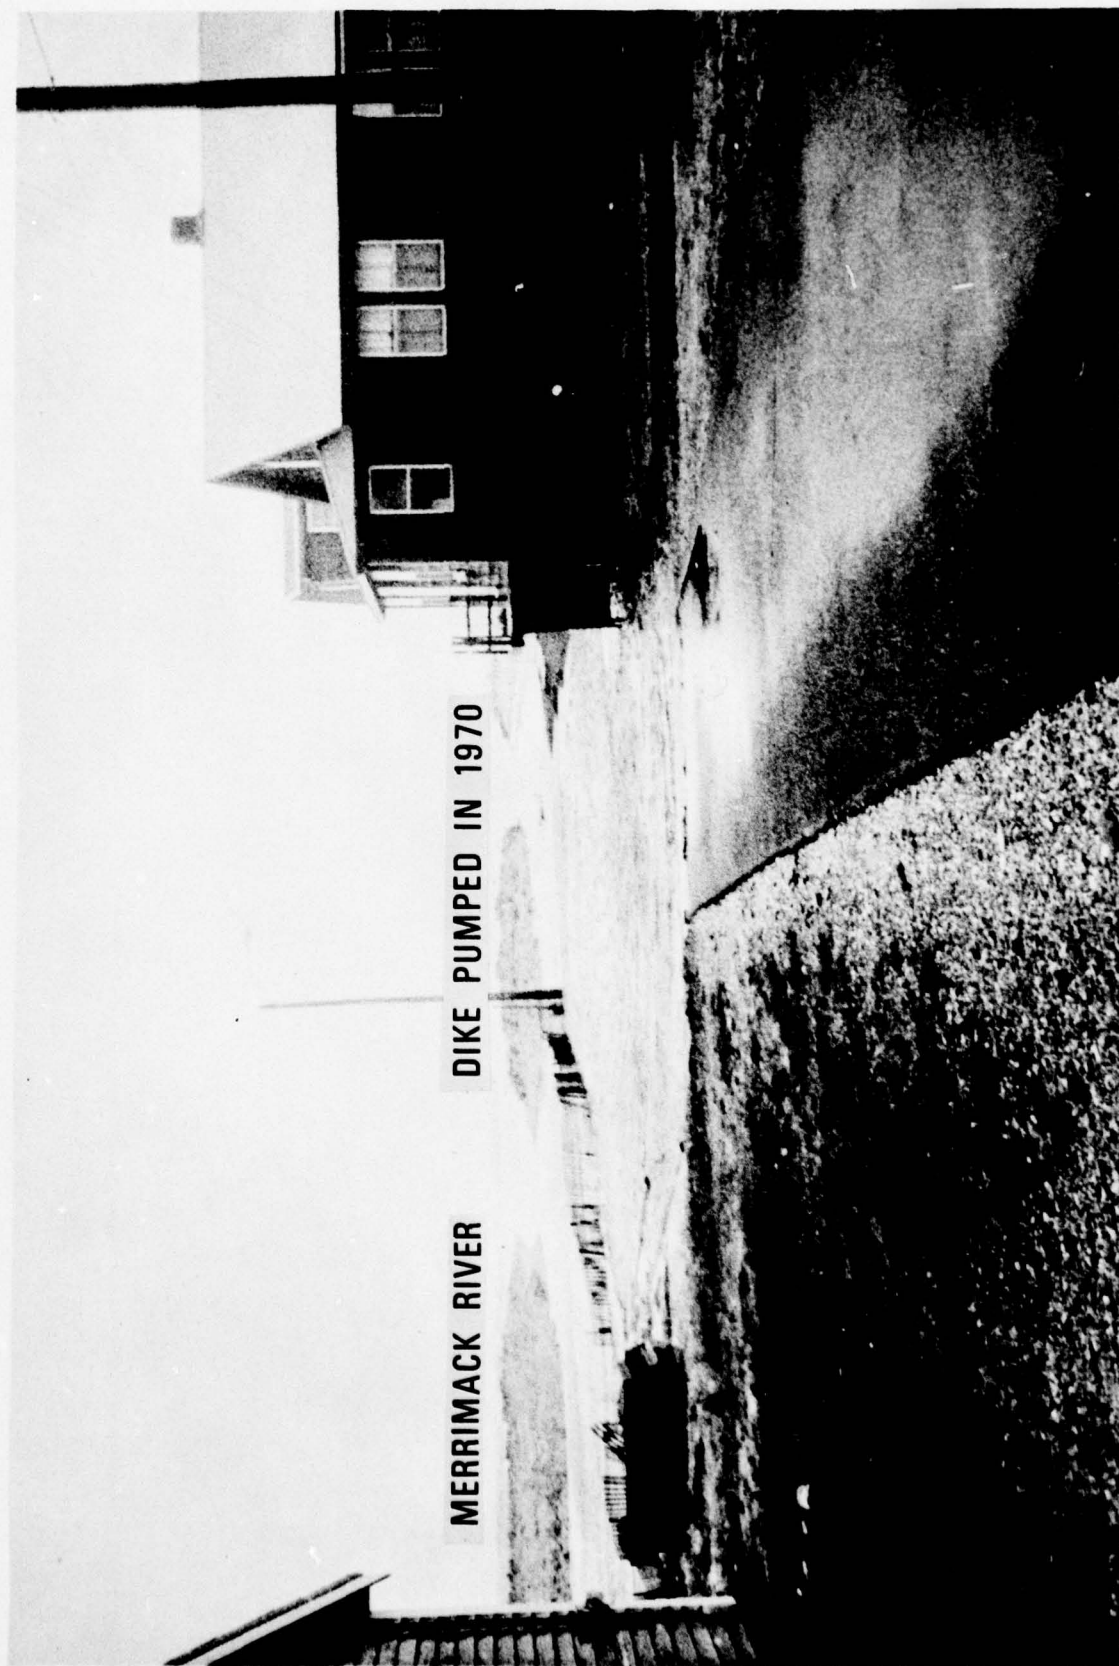
Photo 16. Storm, December 1974, water washed over dike along the south shore of Merrimack River causing flooding of several homes located behind the dike.

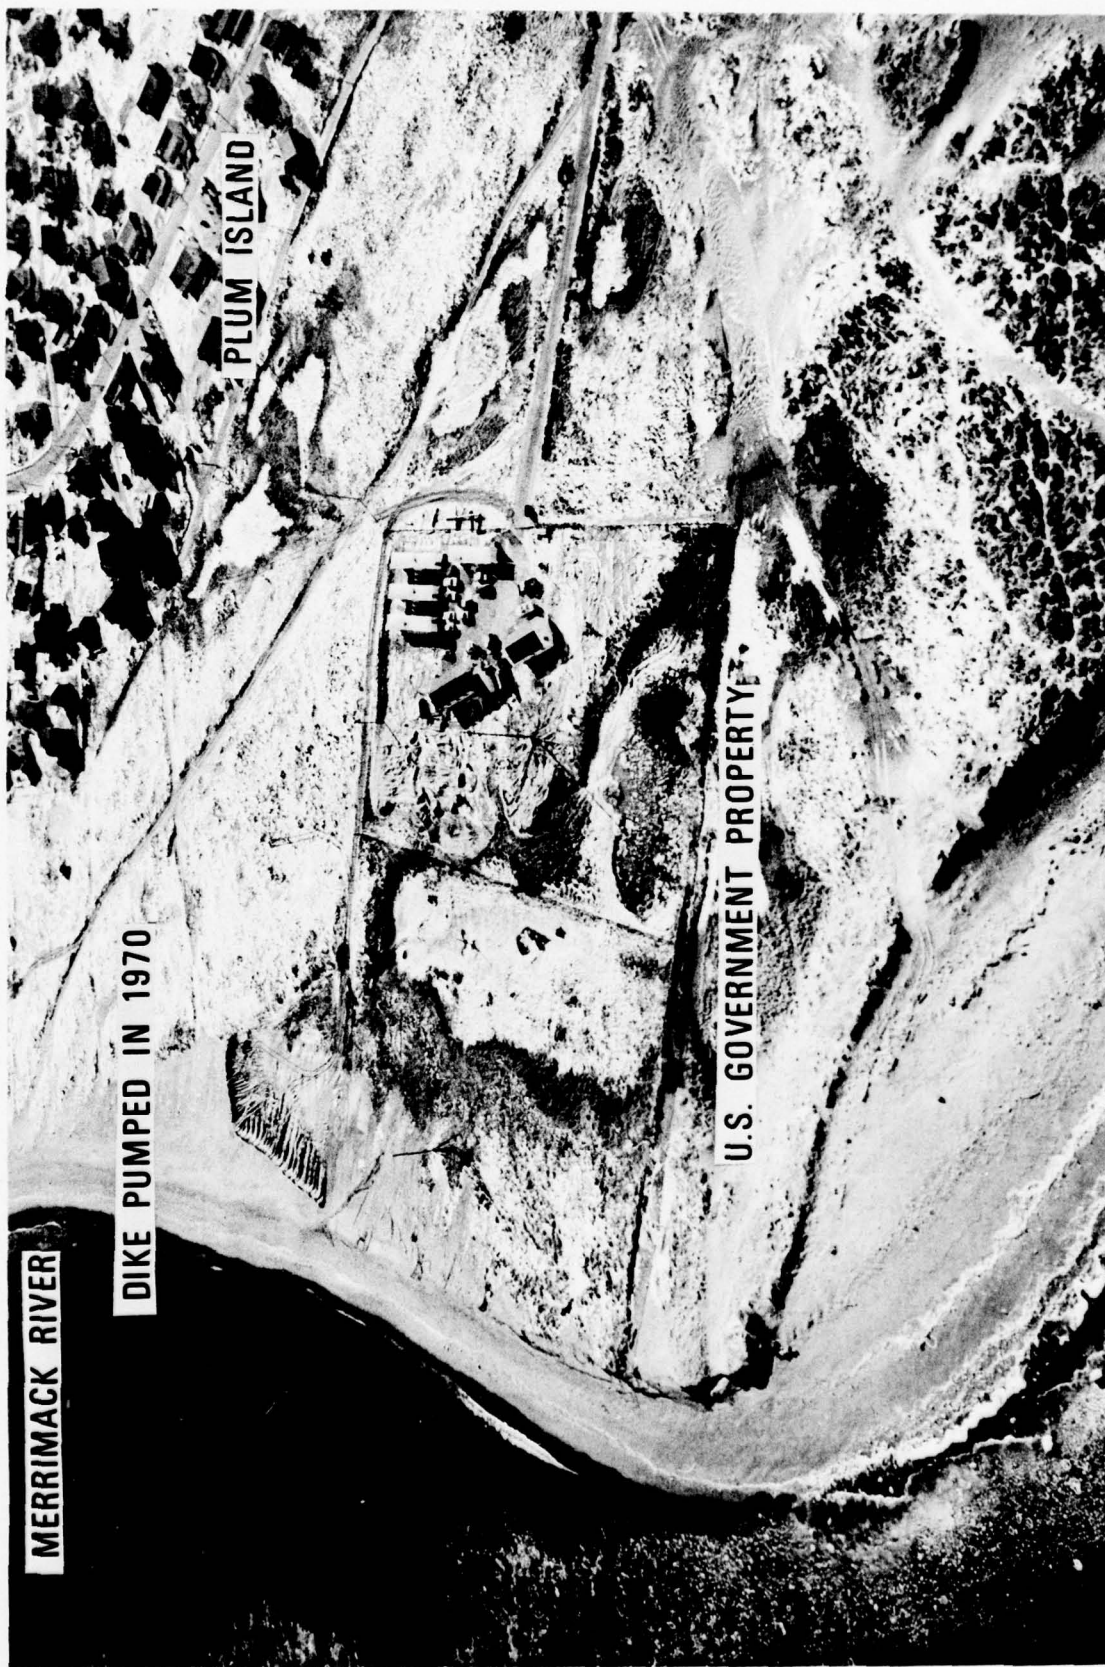
Photo 17. South shore of Merrimack River, U.S. Coast Guard property in the Fall of 1969 just after 2 series of storms that caused extensive damage on Plum Island. (See Photo 18.)

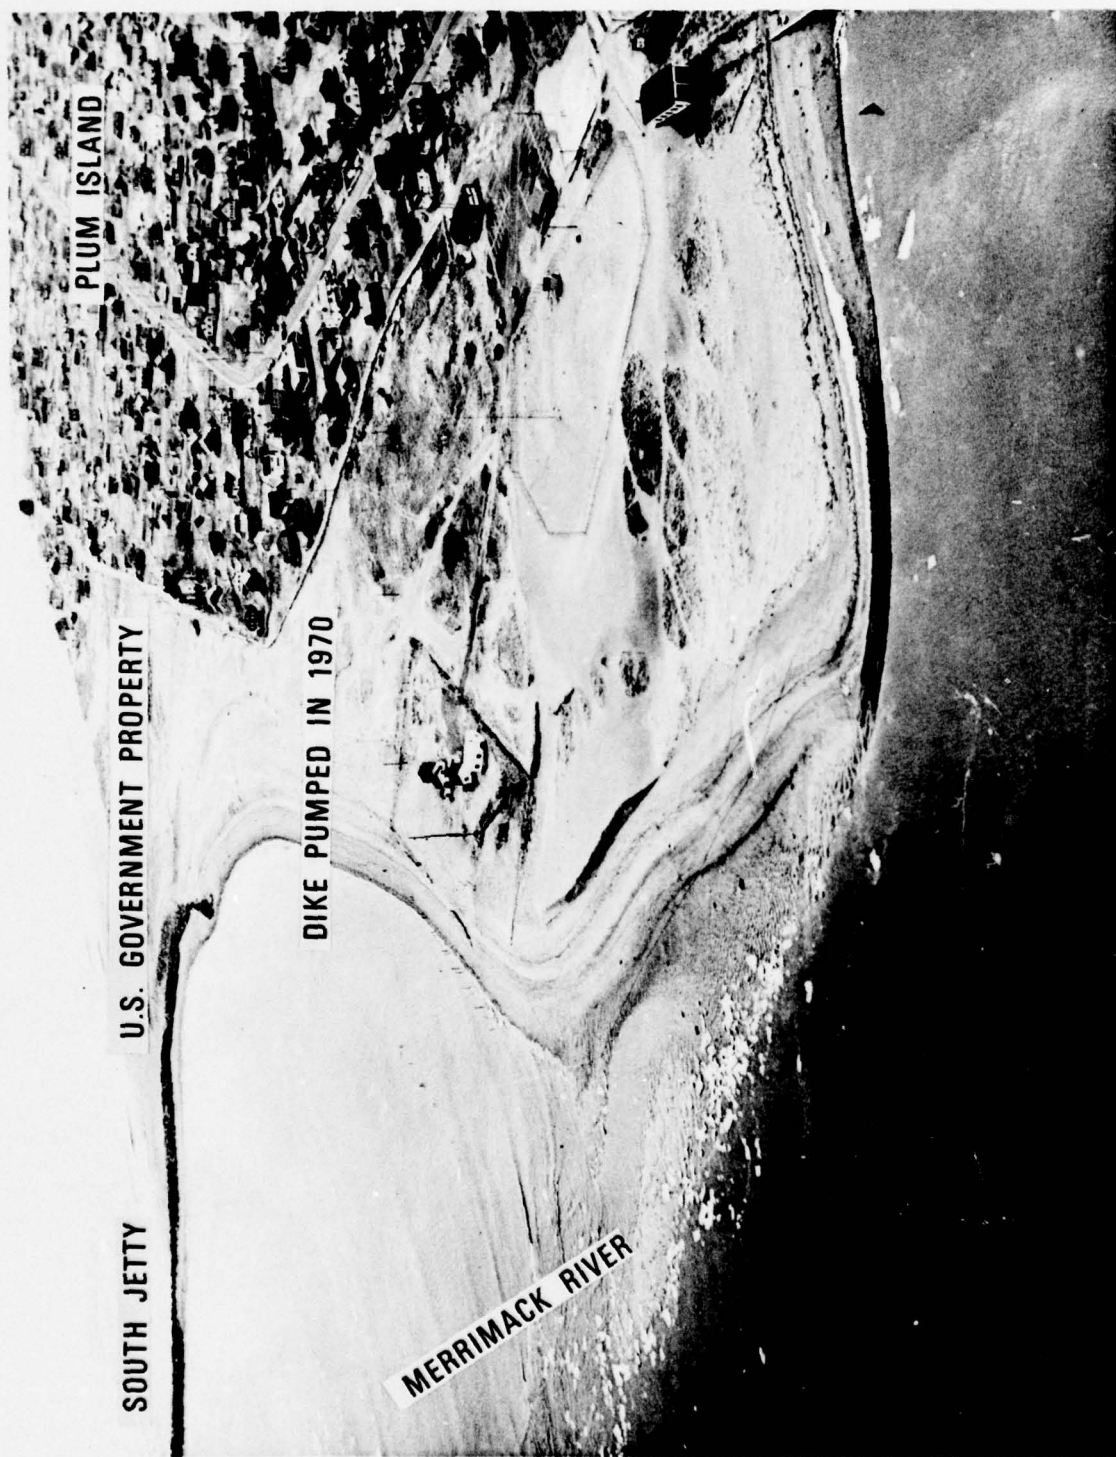
Photo 18. Looking southeast at U.S. Coast Guard property in February 1976. The erosion is continuing resulting in a loss of valuable backshore dunes. (See Photo 17).

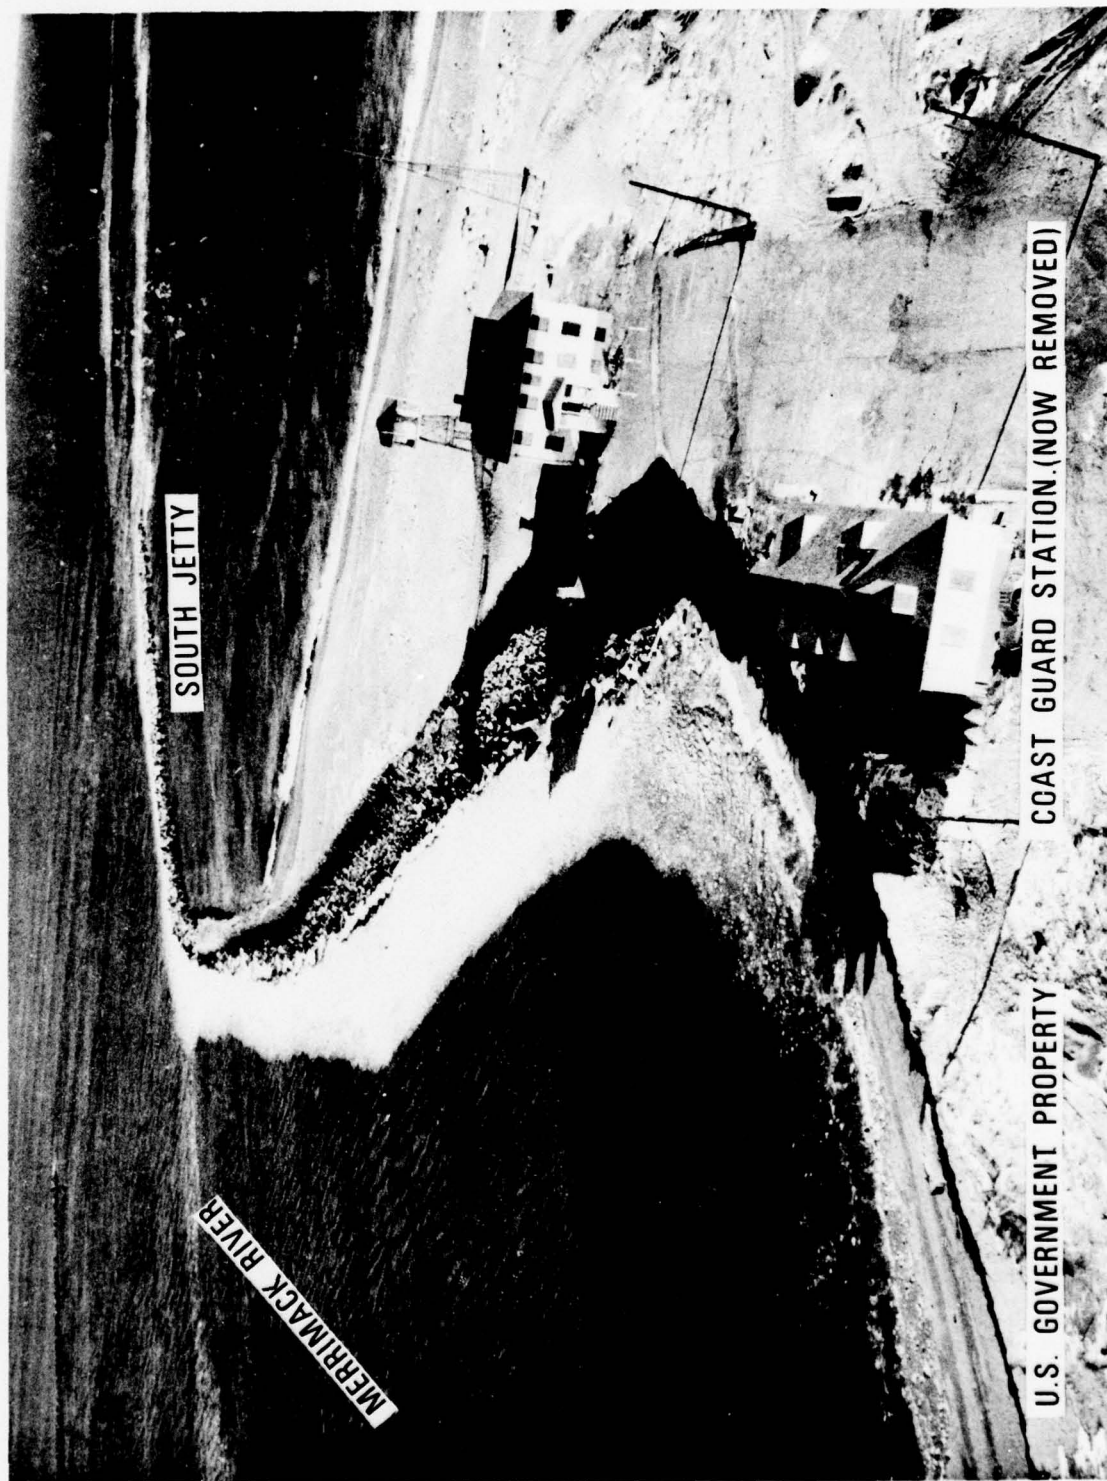
Photo 20. Looking east at U.S. Government property after a series of northeast storms in 1969. (For before photo, see Photo 19).

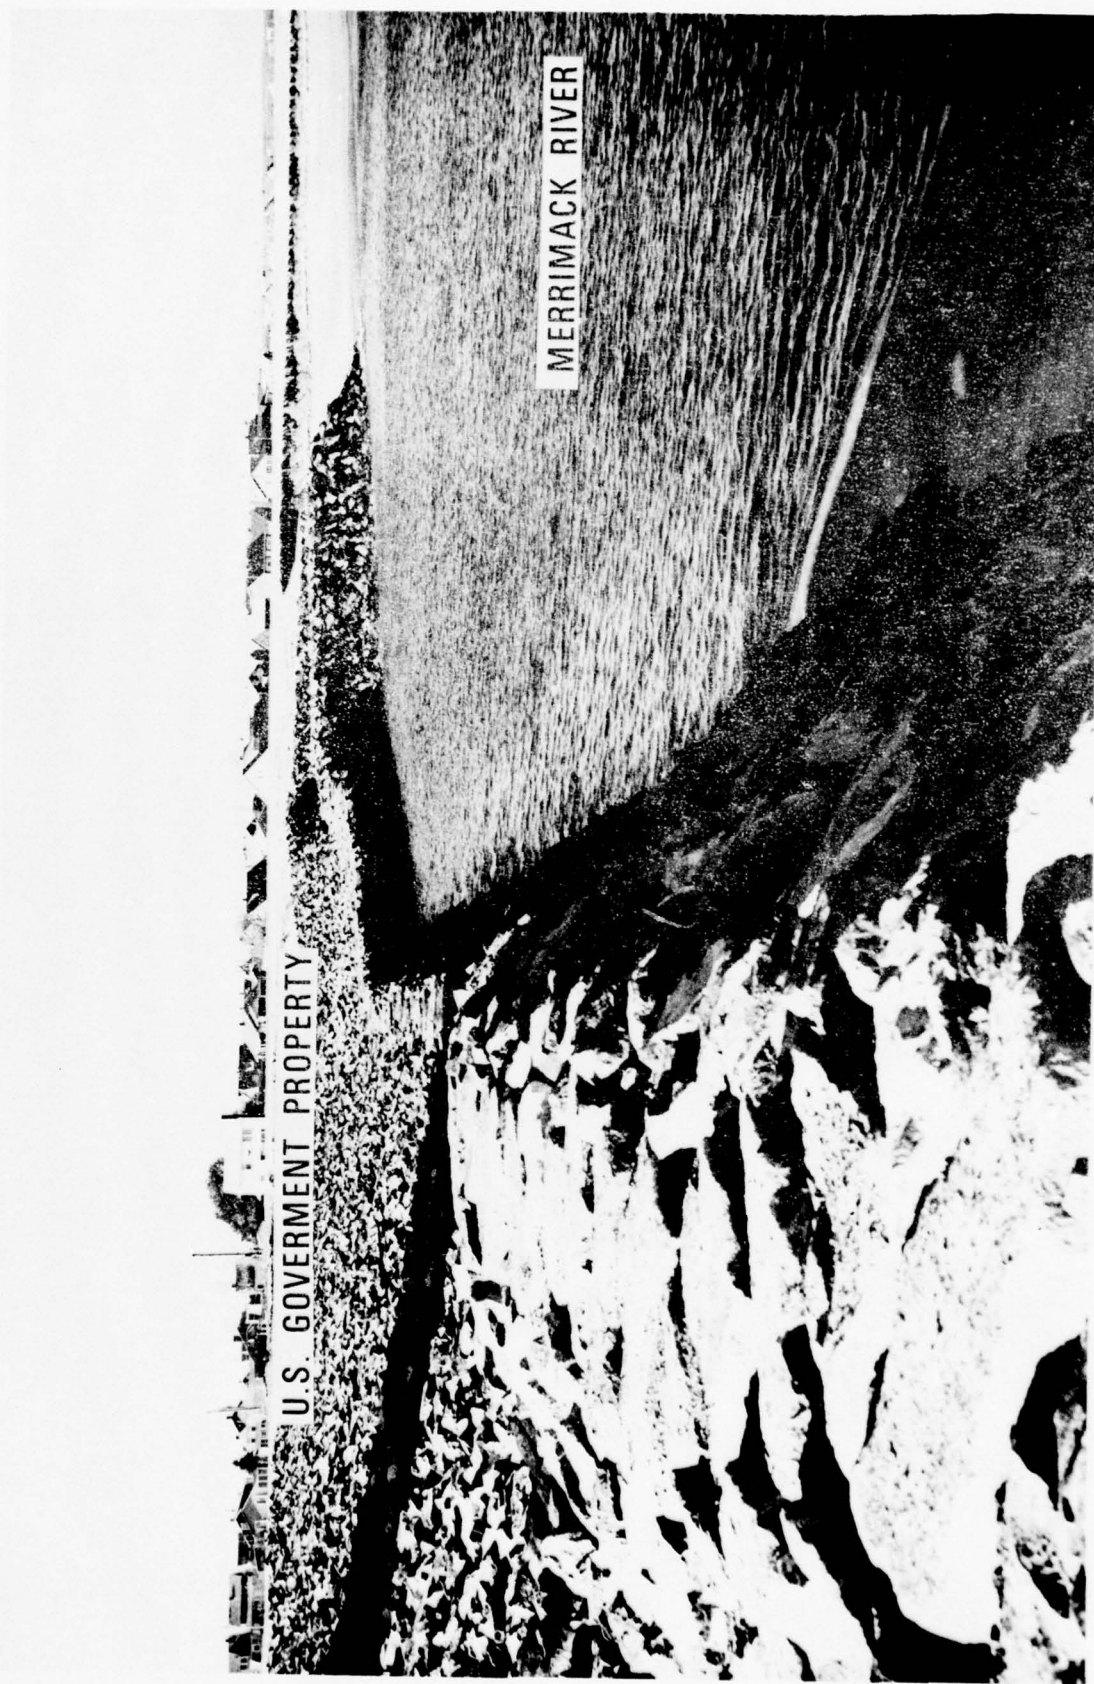
Photo 21. South shore of the Merrimack River revetment constructed by the Corps in 1970 to prevent flanking of the south jetty.

In 1969, following a series of severe winter storms that caused extensive erosion along the south shore of the mouth of the Merrimack River, a special study was completed which recommended that a revetment be placed along the shore in the vicinity of the U.S. Coast Guard Station to protect it from being lost, and to protect the Federal south jetty structure from being flanked. The work was done in 1970.
